FLOOR RENOVATION

Villa Borromeo Arese
Cesano Maderno (MI)

Description of the work done on the wooden floors

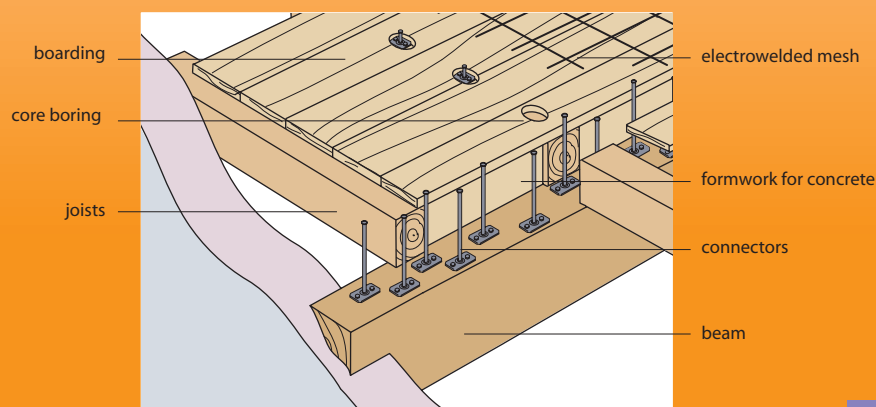
The renovation of the floors of the building presented considerable difficulties: the primary aim was to preserve and renew the existing floors in order to make them suitable for the new use to which the rooms were to be put and which required an increase in load capacity and rigidity (some parts of the building are now used by a university). The load capacities of a residential building are different from those of a public building, especially when some areas are planned to be used as a library. The old floors were built either with a double frame of beams and joists or with a single frame of beams and 3 cm thick boards nailed over them.

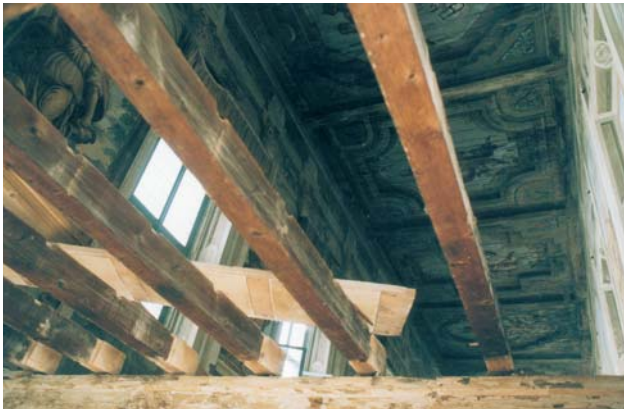
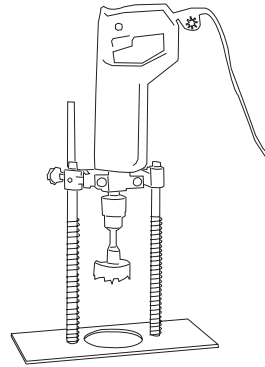
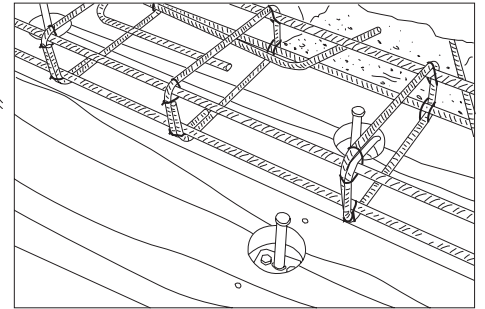
1. Removal of flooring and any substrate over the floor
2. Removal of the floorboards on the main beam

3. Partial cutting of the overlying joists in order to leave an approximately 15cm wide channel over the beams
4. Extrados cleaned
5. Holes drilled at the indicated distances for the connector screws
6. Connectors fixed
7. Frame or reinforcing material laid (where required)
8. Installation of formwork for retaining the concrete poured into the channel over the beams
9. Shoring the beams and joists
10. Laying the electro-welded mesh
11. Pouring the concrete

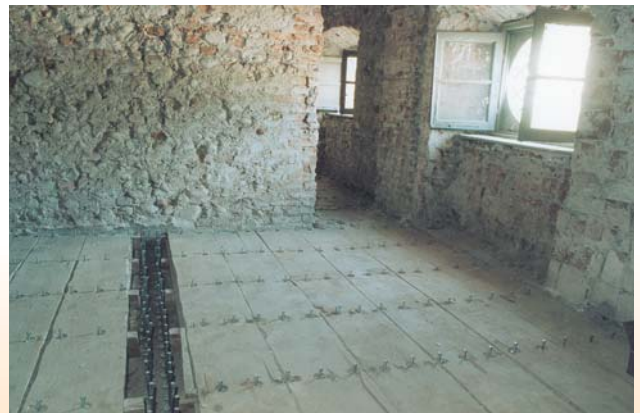
The ideal solution for renovating the floors was to achieve the required rigidity by applying a thin slab of concrete (about 5 cm thick) which was made to collaborate with the wooden elements by means of Tecnaria connectors. Before pouring the concrete, these elements were secured by inserting special sleeper screws into the wooden beams. These connecting elements (with a height of approximately $2/3$ of that of the concrete slab) make the beams integral and mechanically joined to the concrete slab, thereby offering a unitary static response and elevated floor performance.

A suitable sized electro-welded mesh was always inserted in the concrete slab. This achieved considerable increases in the rigidity and load bearing capacity of the floors, together with reduced impact vibrations and creep. Given the presence of frescoes of considerably artistic value, retaining the original level of the floors was a crucial condition.

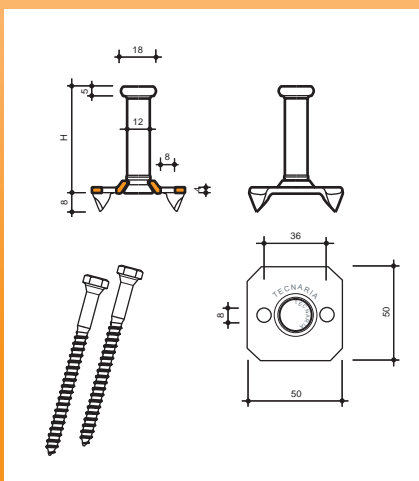
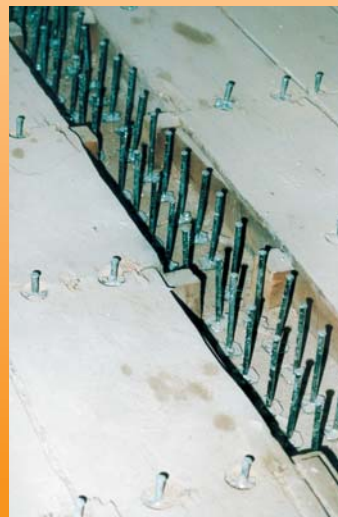
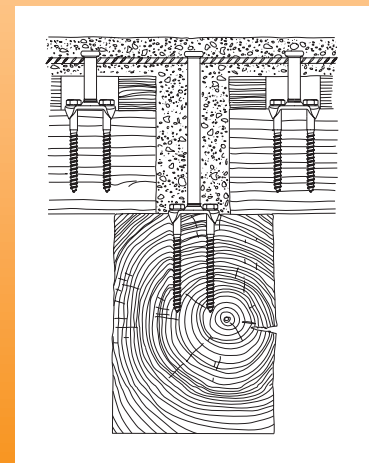
connector in direct contact with the beam and on the joists
